HISTORIC AMERICAN BUILDINGS SURVEY
INVENTORY

2. NAME *Orrin Thompson Mansion*

DATE OR PERIOD *1832*
STYLE *Greek Revival*
ARCHITECT
BUILDER *Orrin Thompson*

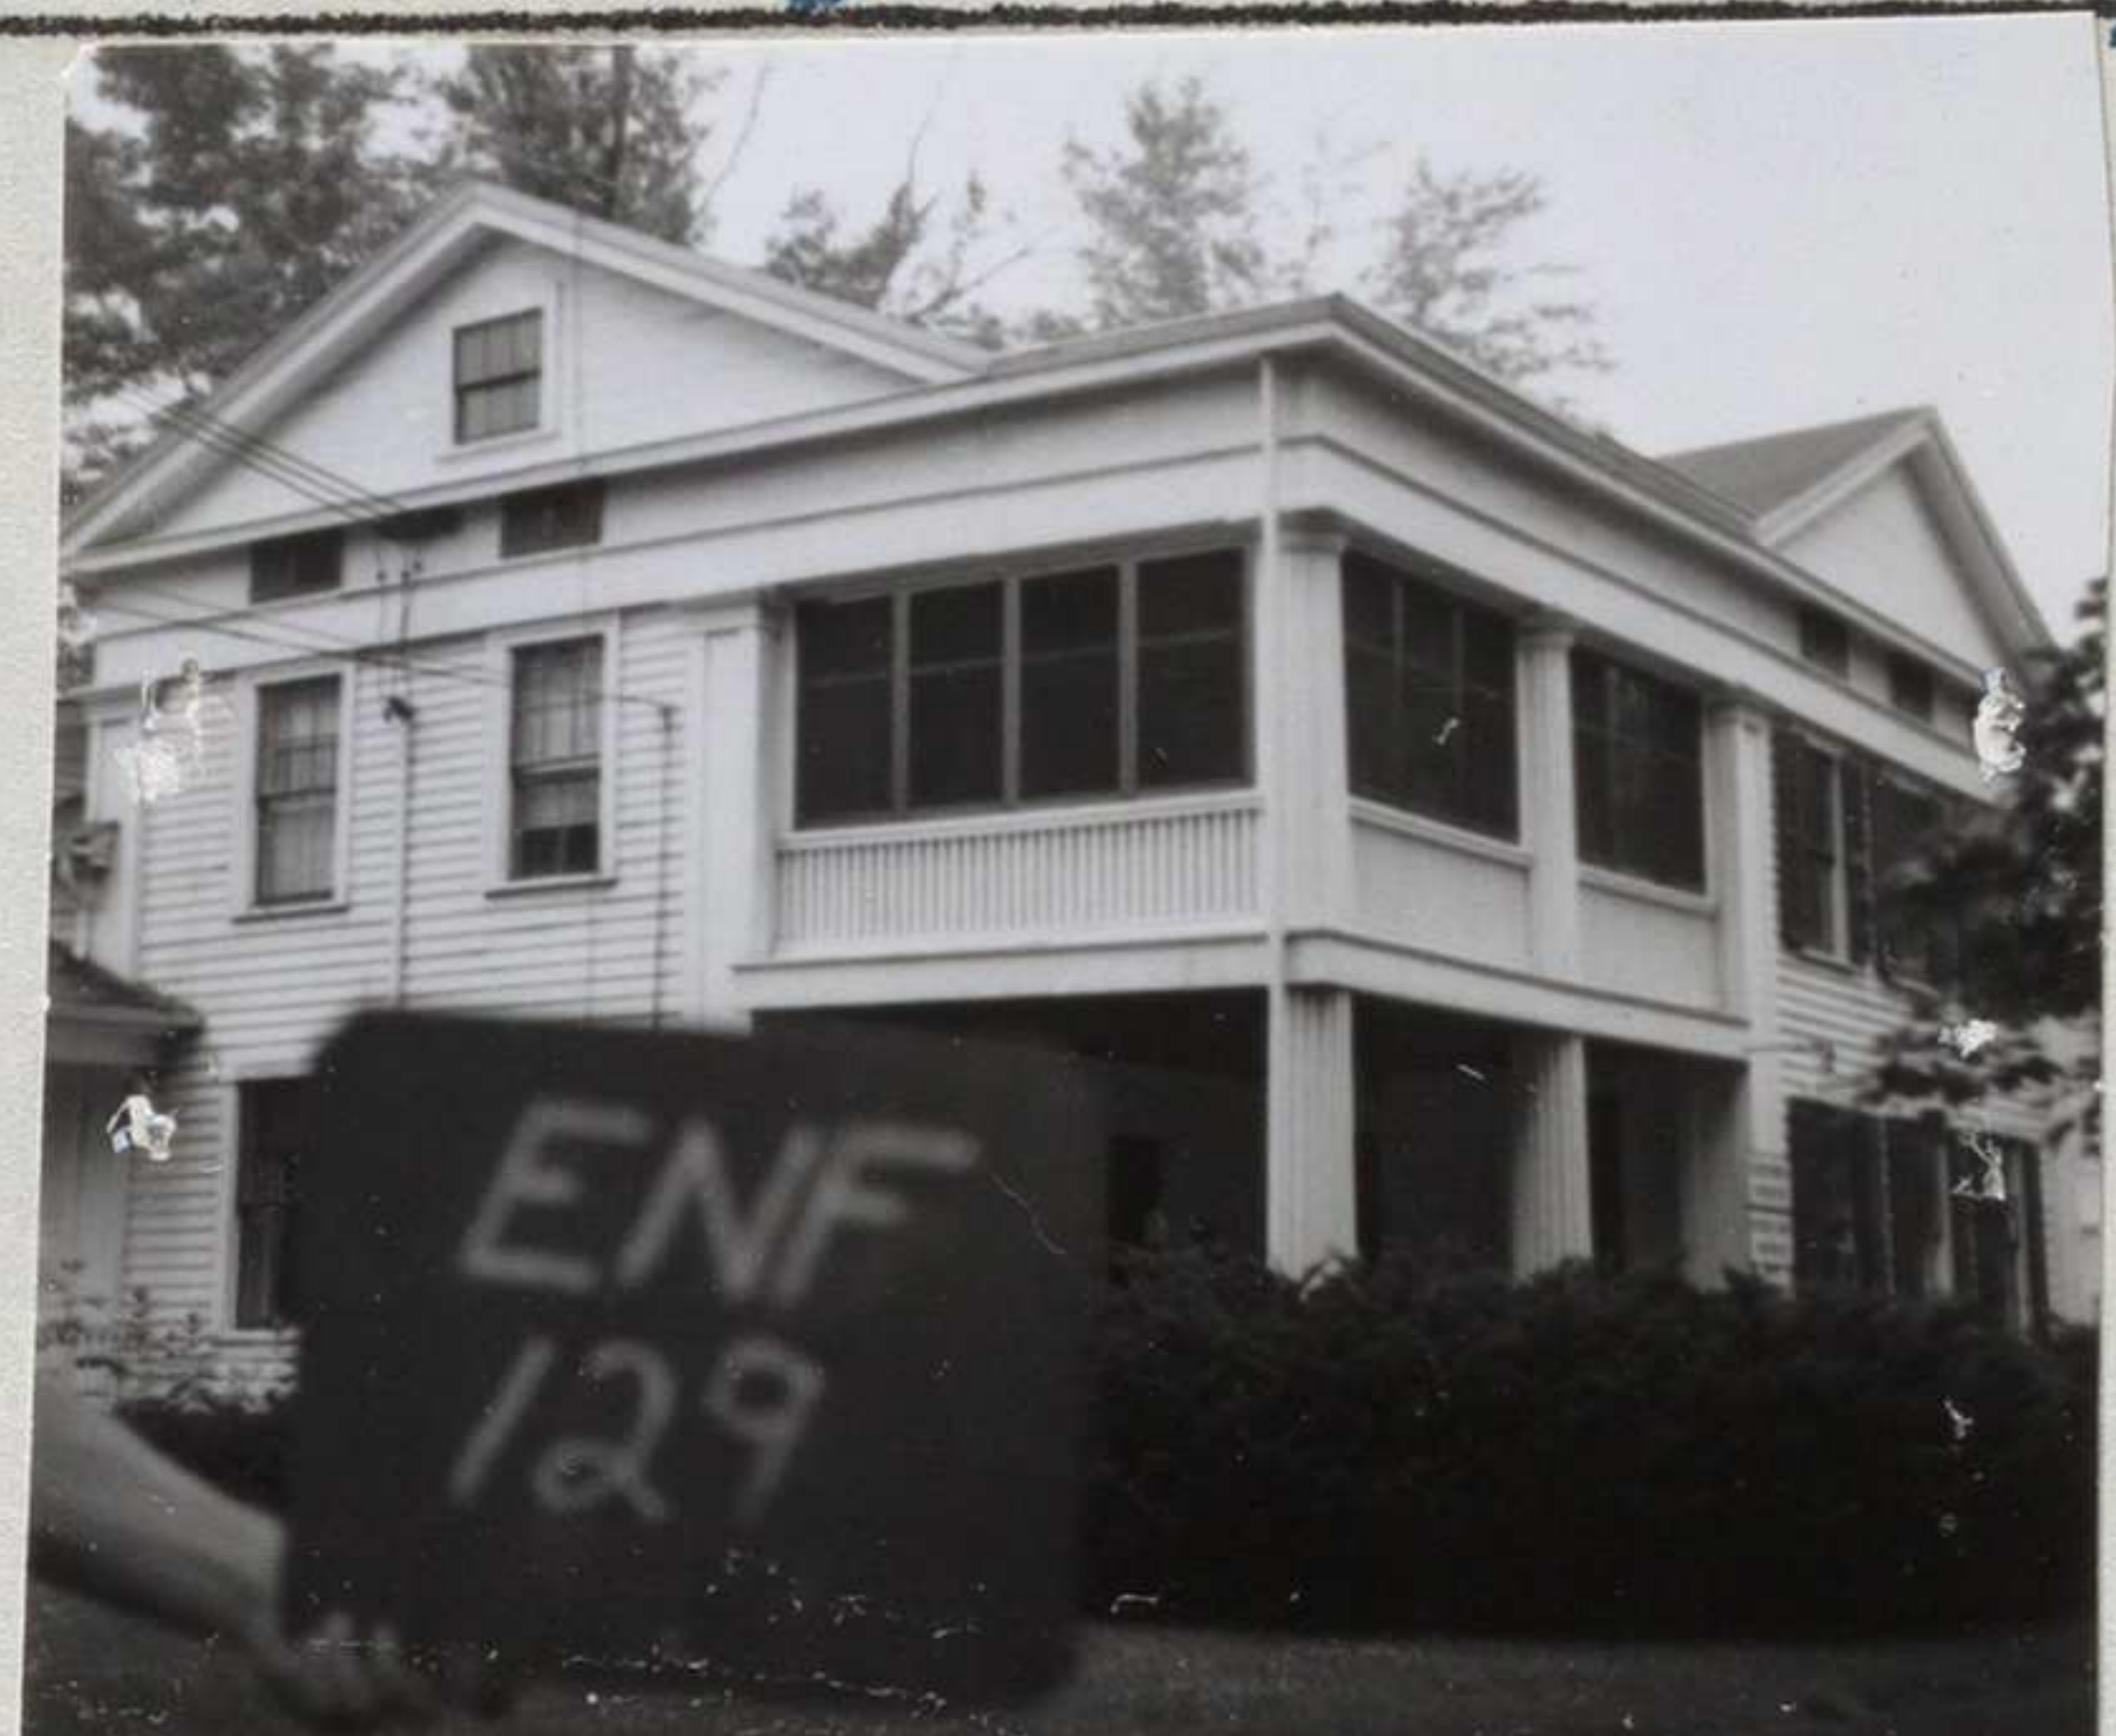
</div>		<div>7. PHOTOGRAPH <i>Enf 129</i></div> <div>

<div>1. STATE <i>CT</i> COUNTY TOWN <i>Enfield</i> VICINITY STREET NO. <i>1060 Enfield Street</i> ORIGINAL OWNER ? ORIGINAL USE <i>Residence</i> PRESENT OWNER ? PRESENT USE <i>Offices</i> WALL CONSTRUCTION <i>Clap board</i> NO. OF STORIES <i>2 1/2</i></div>		<div>HISTORIC AMERICAN BUILDINGS SURVEY INVENTORY</div> <div>2. NAME DATE OR PERIOD <i>1860?</i> STYLE <i>Greek Revival</i> ARCHITECT BUILDER</div> <div>3. FOR LIBRARY OF CONGRESS USE</div>	
<div>4. NOTABLE FEATURES, HISTORICAL SIGNIFICANCE AND DESCRIPTION</div> <div><i>The sign on this house tells us the house was built in 1800. The sign is almost certainly wrong. Built on a brownstone foundation this L-shaped has 3 bays to the front. The shallow pitched roof forms pediments which are plain boarded and supported on a plain entablature and pilasters. The half windows are shuttered and placed in the entablature. The other windows are 6/6 and framed in block cornered moldings. The NE corner of the house has a fine two-story Greek doric porch, the 2nd story being a later addition.</i></div>		<div>OPEN TO PUBLIC <i>No</i></div> <div>

<div>5. PHYSICAL CONDITION OF STRUCTURE</div>		<div>Endangered <i>No</i> Interior <i>fair?</i> Exterior <i>good.</i></div>	
<div>6. LOCATION MAP (Plan Optional)</div> <div>

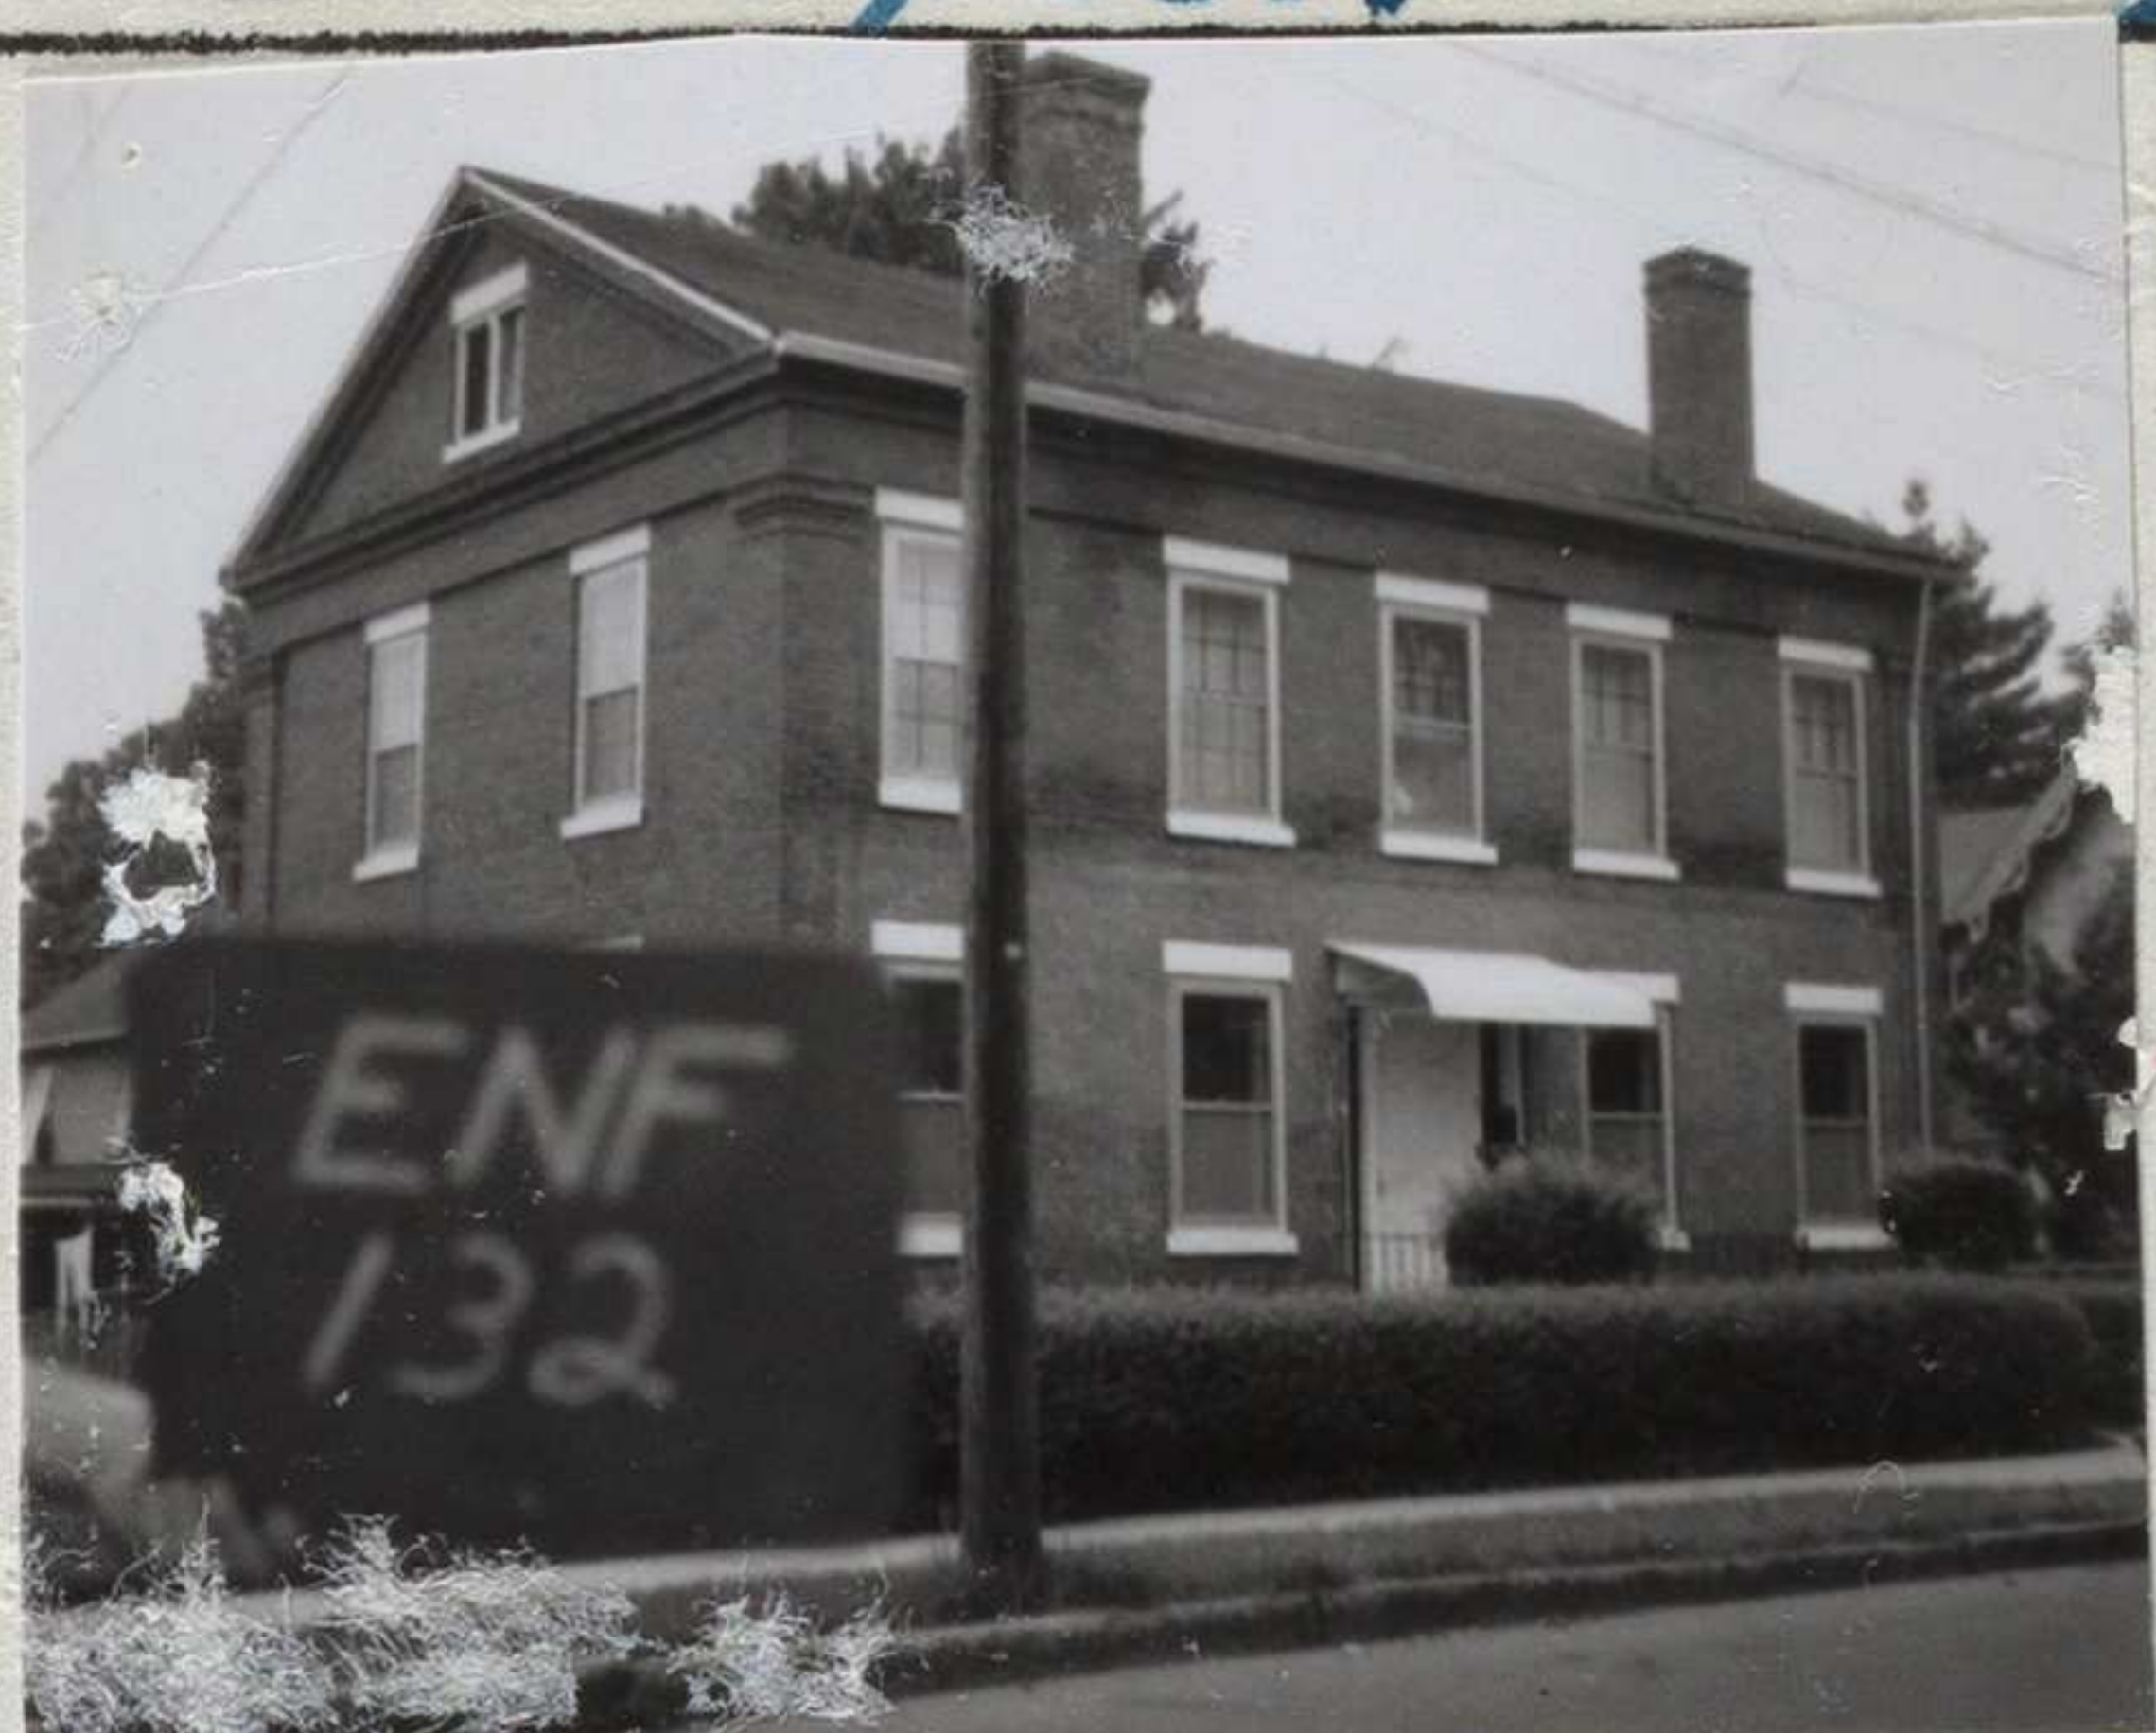
<p>7. PHOTOGRAPH <i>Enf 132</i></p>

<p>1. STATE <i>Ct</i> COUNTY TOWN <i>Enfield</i> VICINITY STREET NO. <i>40 Prospect Street</i></p> <p>ORIGINAL OWNER? ORIGINAL USE <i>Residence</i> PRESENT OWNER? PRESENT USE <i>Residence</i> WALL CONSTRUCTION <i>brick</i> NO. OF STORIES <i>2</i></p>		<p>HISTORIC AMERICAN BUILDINGS SURVEY INVENTORY</p> <p>2. NAME</p> <p>DATE OR PERIOD <i>1860</i> STYLE <i>late Greek Revival</i> ARCHITECT BUILDER</p> <p>3. FOR LIBRARY OF CONGRESS USE</p>			
<p>4. NOTABLE FEATURES, HISTORICAL SIGNIFICANCE AND DESCRIPTION</p> <p><i>This late Revival brick house is five bays wide. The roof is shallow pitched and supported on pilasters and entablature form in brick. The windows are 6/6 and have painted brownstone lintels and sills. The door has full length sidelights. Chimneys occur between the 1st + 2nd and 4th + 5th bays right above the facade wall.</i></p>		<p>OPEN TO PUBLIC <i>No</i></p>			
<p>5. PHYSICAL CONDITION OF STRUCTURE</p> <p>Endangered ? Interior <i>poor?</i> Exterior <i>poor</i></p>		<p>6. LOCATION MAP (Plan Optional)</p>

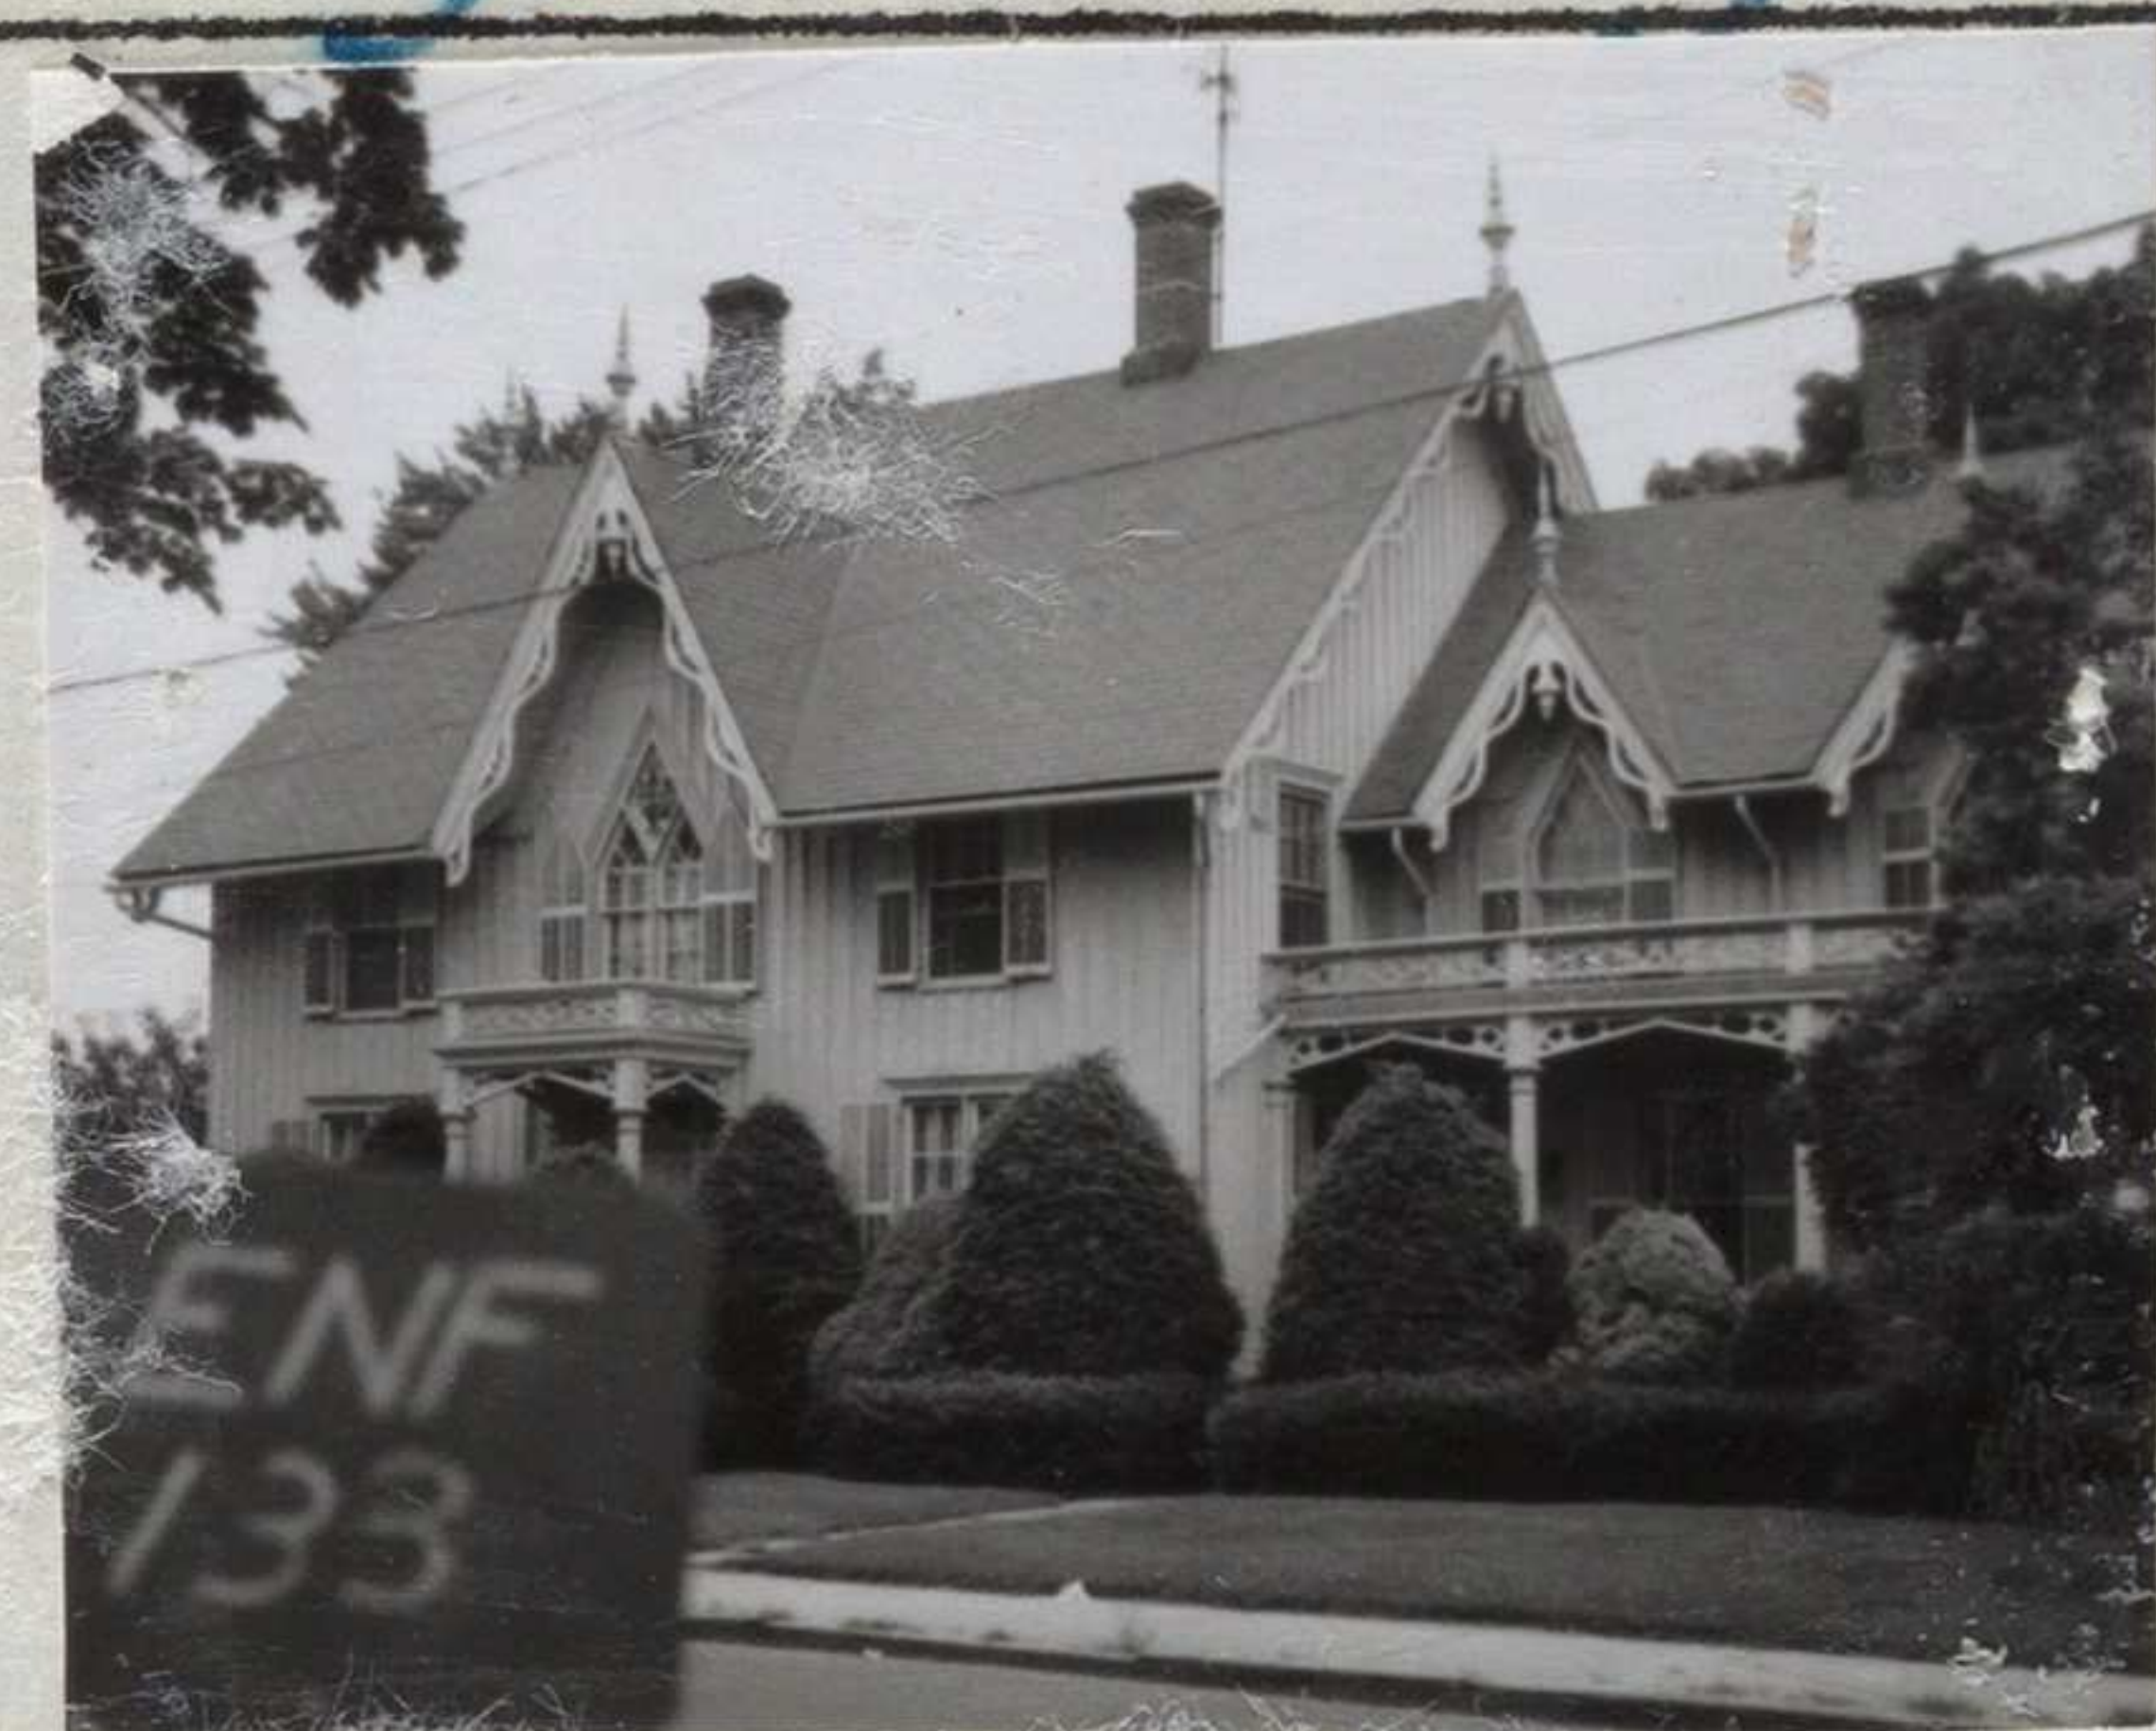
<p>7. PHOTOGRAPH <i>Enf 33</i></p>

<p>1. STATE <i>CT</i> COUNTY TOWN <i>Enfield</i> VICINITY STREET NO. <i>36 Prospect St.</i></p> <p>ORIGINAL OWNER ? ORIGINAL USE <i>Residence</i> PRESENT OWNER ? PRESENT USE <i>Residence</i> WALL CONSTRUCTION <i>board + batten</i> NO. OF STORIES <i>2</i></p>		<p>HISTORIC AMERICAN BUILDINGS SURVEY INVENTORY</p> <p>2. NAME</p> <p>DATE OR PERIOD <i>Carpenter Gothic Rev.</i> STYLE <i>1870?</i> ARCHITECT BUILDER</p> <p>3. FOR LIBRARY OF CONGRESS USE</p>	
<p>4. NOTABLE FEATURES, HISTORICAL SIGNIFICANCE AND DESCRIPTION</p> <p><i>This the most intriguing building we've surveyed of the latter 19th century. The board and batten structure is built on a brick foundation. There are three bays to the main section and three to the North ell. The roof is of a steep pitched slope with gables over pointed windows of the central main bay and two ell 2nd story windows. All gables are decorated with barge boards. There are two central chimneys. The shuttered windows are mainly 6/6 except when they are double. The main door has both transom and sidelights, the door itself being in two full length panels. There is a decorated porch to the side on the ell. The</i></p> <p>OPEN TO PUBLIC <i>No</i></p> <p><i>Illus. over</i> ✓</p>

<p>5. PHYSICAL CONDITION OF STRUCTURE</p> <p>Endangered ? Interior <i>good</i> Exterior <i>good</i></p>			
<p>6. LOCATION MAP (Plan Optional)</p>

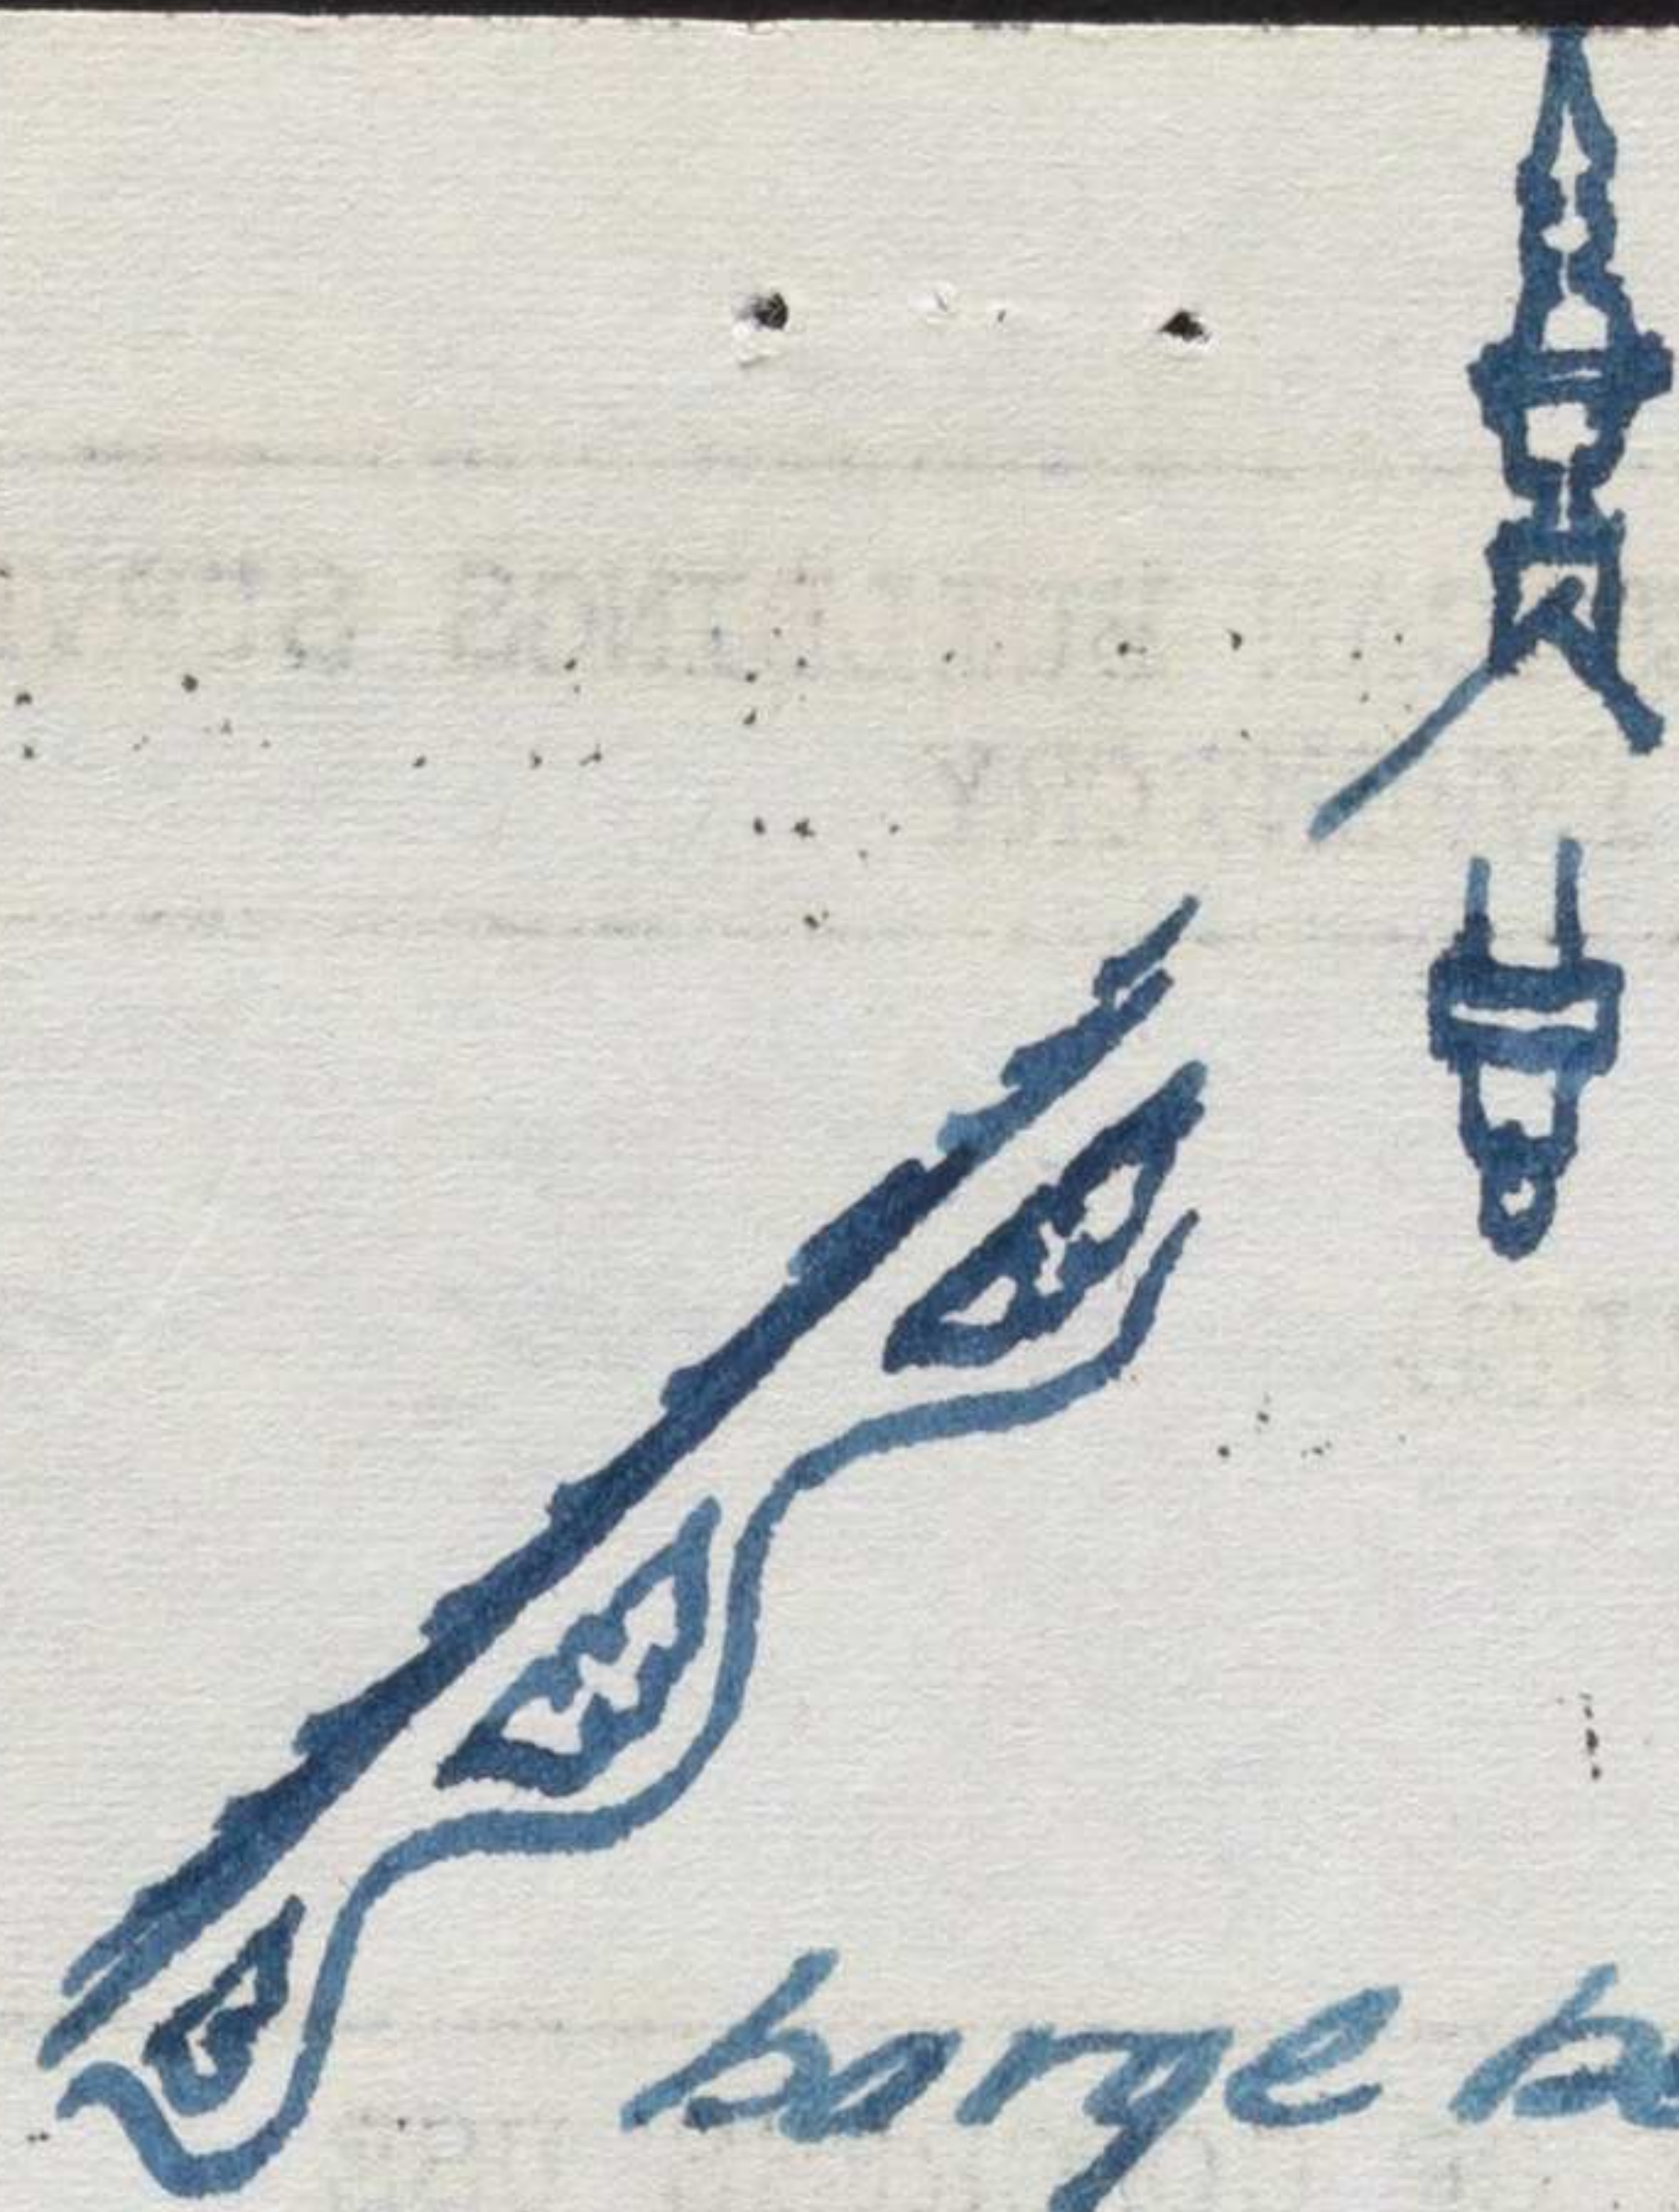
barge boards.

*windows are covered with simple gothic
lintels. Fine Carpenterwork appears in both
the side porch and portico.*

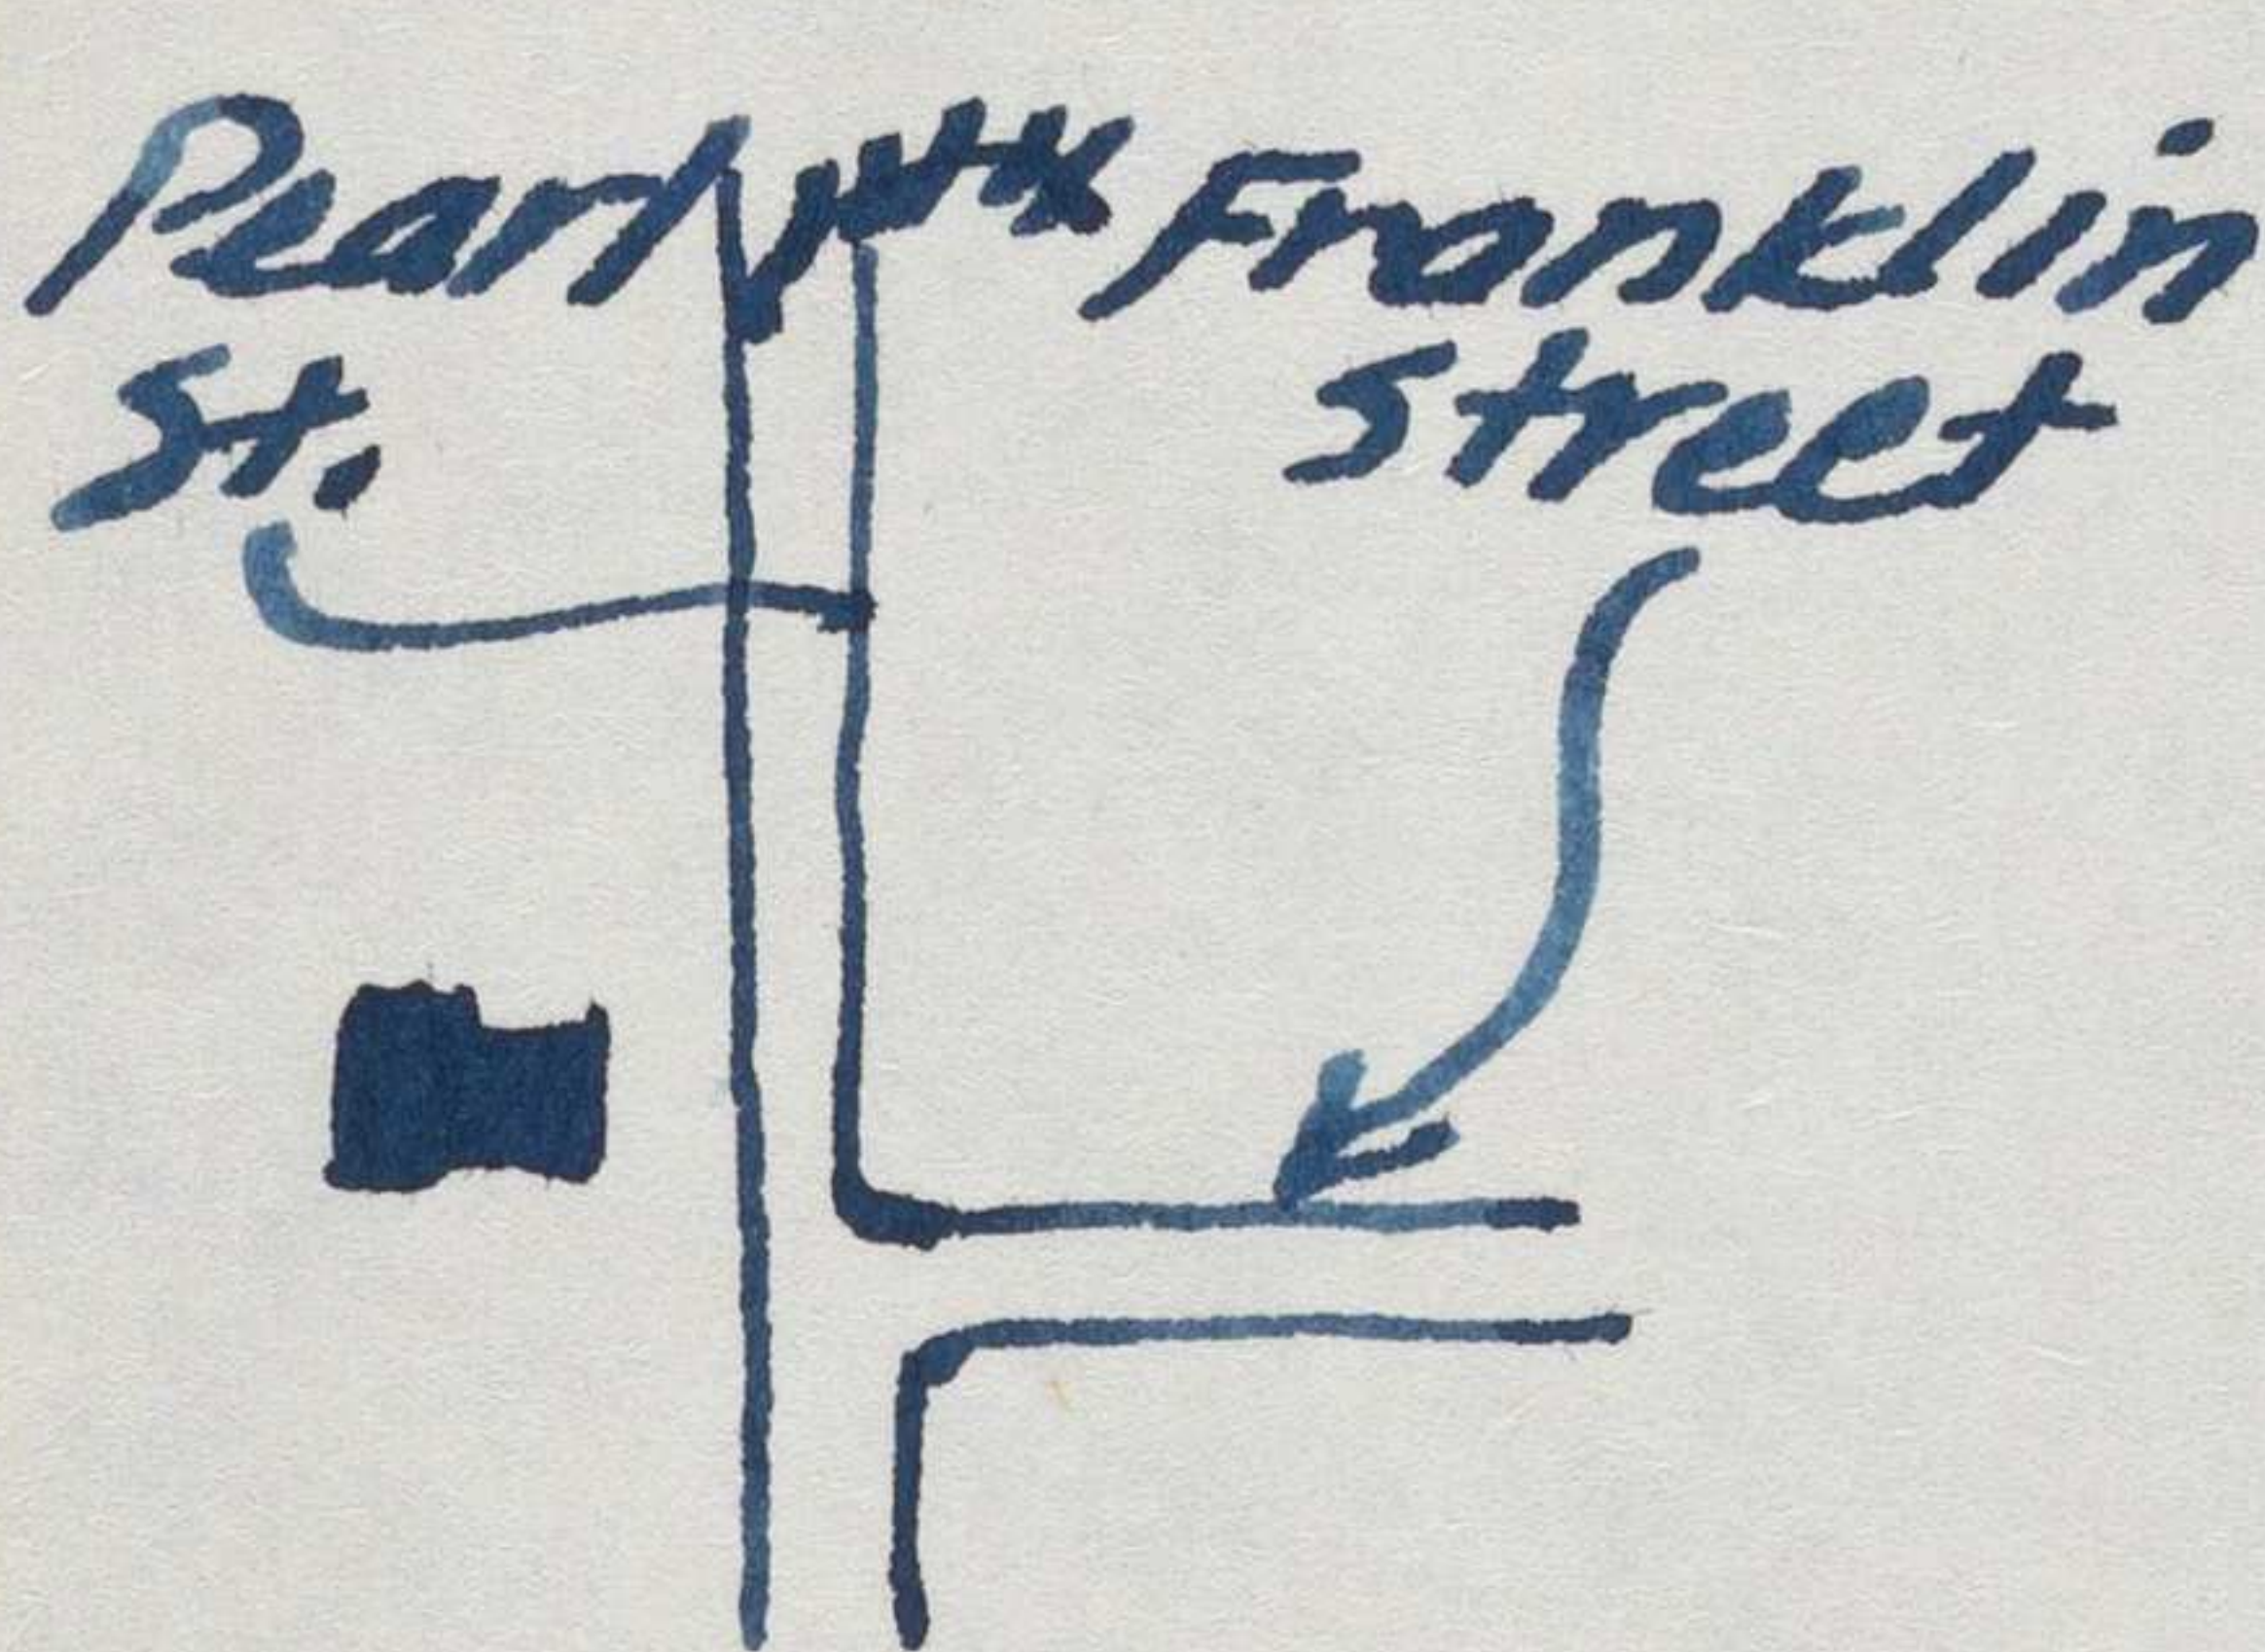
7. PHOTOGRAPH *Enf135*8. PUBLISHED SOURCES (Author, Title, Pages)
INTERVIEWS, RECORDS, PHOTOS, ETC.9. NAME, ADDRESS AND TITLE OF
RECORDER

This L-shaped house is built on a brick foundation. The facade and South side are decorated with bay windows. The other windows are 2 1/2. The roof is very flat with wide eaves supported on brackets in a wide entablature. The nicest feature of the house is the SW. 2 story porch with its scroll work balustrade.

Endangered *No* Interior *fair?* Exterior *good*
